**Flood Control Project Maintenance
Levee Inspections**
LMA District Cover Sheet
Spring 2017 Levee Inspection Results

Reclamation District No. 0787 Fair

Levee Inspection Report By Mile - Spring 2017

Waterway	Bank	Unit Miles	Inspection Start/End	Inspector
Unit No. 01 Colusa Basin Drain	Left	4.45	05/04/2017 05/04/2017	Zach Jojola

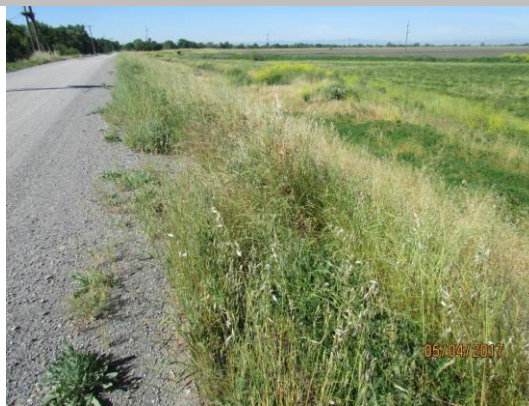
Photo 1 of 1 : SP_2017_RD0787_212_5_20170504_00012.jpg

LM Start	0.01	Rating **	U	Issue No.	5
LM End	4.42	Issue Type +	Ma	Location *	LS
Category	Earthen Levee			GPS Latitude/Longitude	
				Start	End
Item	Vegetation			38.799538 °	38.822494 °
				-121.725573 °	-121.795599 °
DWR ID	DWR_RD0787_01_s_2017_5				
Comment Code					
V1 : Control annual grass and weeds on the levee slopes and easements.					
Inspector Comment

Tall grass on landside levee slope, blocking visibility. Spring 2017.

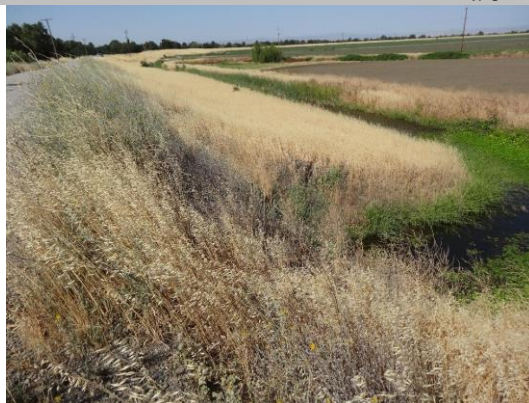
Photo 1 of 3 : UCIP_SP_2017_37585_68154.jpg

Comment Code					
Inspector Comment					
FS_ID:37585 DS_ID:22892 EP_NO: 9392 Repair Type: Non-Urgent Crossing Status: Found UCIP Comments: Dense vegetation limits the inspector's visibility to identify signs of pipe failure (leaks) along the slope. Recommend removing vegetation along pipe alignment to conduct proper inspection of structure. FIELD_STRUCT_DESC: 36-inch concrete pipe through the levee 17.0 feet below the crown. Slide gate in 36-inch standpipe on the waterward side (App. 9392 - River Garden Farms). 24-inch pipe from standpipe to pump house mounted on steel structure in channel. Pump and 24-inch steel pipe installed on the waterward side, 1962 (App. 3878 - river Garden Farms). FS Date: 6/10/2014

View of landward slope.

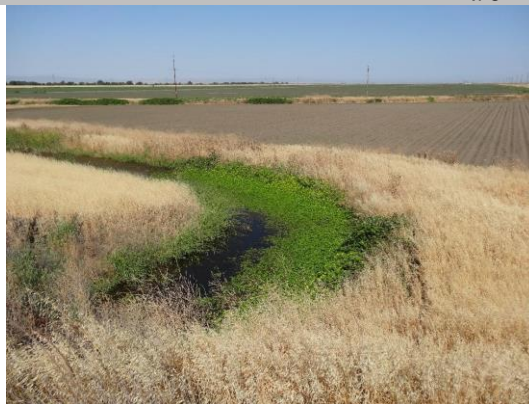
Photo 2 of 3 : UCIP_SP_2017_37585_68153.jpg

View of landward side.

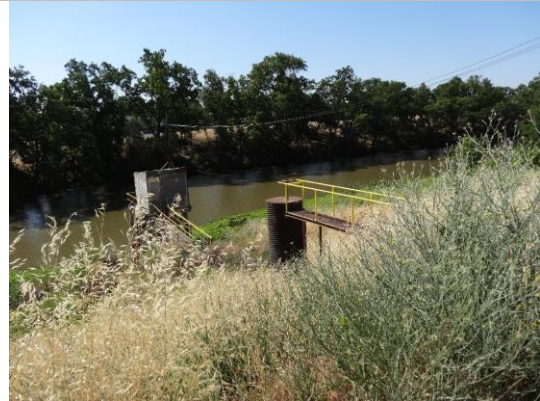
Photo 3 of 3 : UCIP_SP_2017_37585_68156.jpg

Comment Code						
Inspector Comment						
FS_ID:37585 DS_ID:22892 EP_NO: 9392 Repair Type: Non-Urgent Crossing Status: Found UCIP Comments: Dense vegetation limits the inspector's visibility to identify signs of pipe failure (leaks) along the slope. Recommend removing vegetation along pipe alignment to conduct proper inspection of structure. FIELD_STRUCT_DESC: 36-inch concrete pipe through the levee 17.0 feet below the crown. Slide gate in 36-inch standpipe on the waterward side (App. 9392 - River Garden Farms). 24-inch pipe from standpipe to pump house mounted on steel structure in channel. Pump and 24-inch steel pipe installed on the waterward side, 1962 (App. 3878 - river Garden Farms). FS Date: 6/10/2014

View of waterward side.

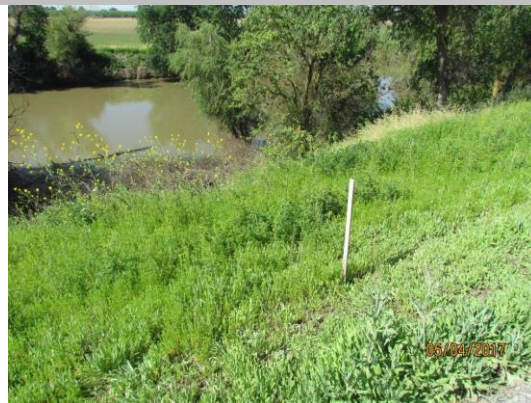
Photo 1 of 1 : SP_2017_RD0787_212_9_20170504_00013.jpg

LM Start	0.73	Rating **	M	Issue No.	9
LM End	0.73	Issue Type +	Ma	Location *	WS
Category	Earthen Levee			GPS Latitude/Longitude	
				Start	End
Item	Slope Stability			38.795814 °	38.795814 °
				-121.736799 °	-121.736799 °
DWR ID	DWR_RD0787_01_s_2017_9				
Comment Code					
S1 : Repair slope instability.					
Inspector Comment					
Multipel cracks visibile on a 50' section of the waterside slope.

View of slope stability location on waterside slope. Spring 2017.

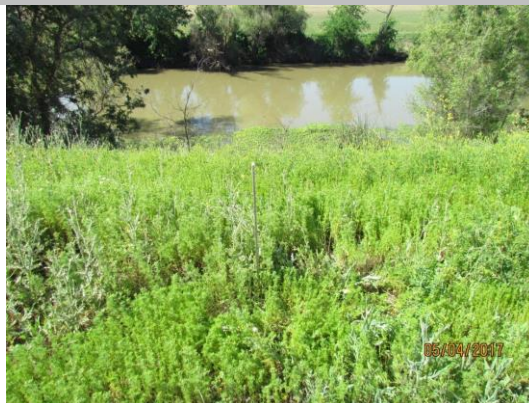
Photo 1 of 1 : SP_2017_RD0787_212_12_20170504_00014.jpg

LM Start	0.75	Rating **	A/W	Issue No.	12
LM End	0.75	Issue Type +	Ma	Location *	WS
Category	Earthen Levee			GPS Latitude/Longitude	
				Start	End
Item	Slope Stability			38.795891 °	38.795891 °
				-121.737098 °	-121.737098 °
DWR ID	DWR_RD0787_01_s_2017_12				
Comment Code					
S1 : Repair slope instability.					
Inspector Comment					
50' crack beginning to develop on wateride slope. Recommend monitoring.

View of slope stability location on waterside slope. Spring 2017.

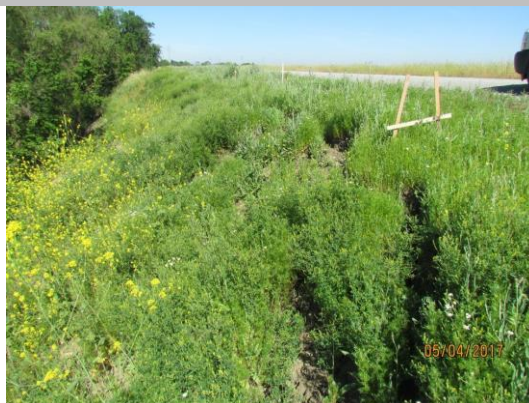
Photo 1 of 1 : SP_2017_RD0787_212_15_20170504_00015.jpg

LM Start	0.77	Rating **	M	Issue No.	15
LM End	0.77	Issue Type +	Ma	Location *	WS
Category	Earthen Levee			GPS Latitude/Longitude	
				Start	End
Item	Slope Stability			38.795996 °	38.795996 °
				-121.737493 °	-121.737493 °
DWR ID	DWR_RD0787_01_s_2017_15				
Comment Code					
S1 : Repair slope instability.					
Inspector Comment					
50' slough section on waterside slope.

View of sloughing on waterside slope. Spring 2017.

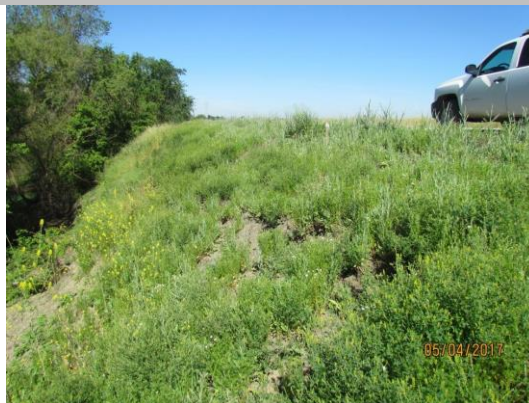
Photo 1 of 1 : SP_2017_RD0787_212_16_20170504_00016.jpg

LM Start	0.78	Rating **	M	Issue No.	16
LM End	0.78	Issue Type +	Ma	Location *	WS
Category	Earthen Levee			GPS Latitude/Longitude	
				Start	End
Item	Slope Stability			38.796042 °	38.796042 °
				-121.737661 °	-121.737661 °
DWR ID	DWR_RD0787_01_s_2017_16				
Comment Code					
S1 : Repair slope instability.					
Inspector Comment					
Sloughing on waterside slope.

View of sloughing on waterside slope. Spring 2017.

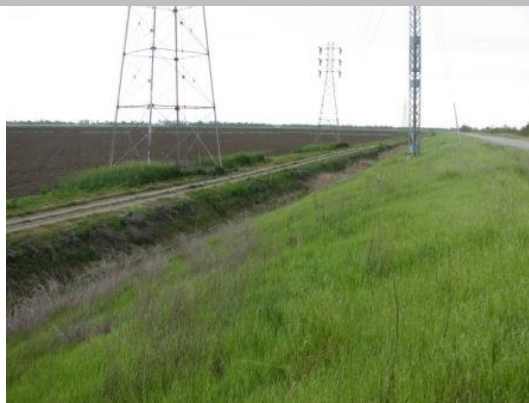
Photo 1 of 3 : SP_2017_RD0787_212_13_20170320_00003.jpg

LM Start	1.58	Rating **	M	Issue No.	13
LM End	2.73	Issue Type +	En	Location *	LS
Category	Earthen Levee			GPS Latitude/Longitude	
				Start	End
Item	Encroachments			38.801794 °	38.809506 °
				-121.750204 °	-121.768979 °
DWR ID	DWR_RD0787_01_s_2012_13				
Comment Code					
DT : Ditch					
Inspector Comment

Agricultural ditch runs along landside the distance of the district.

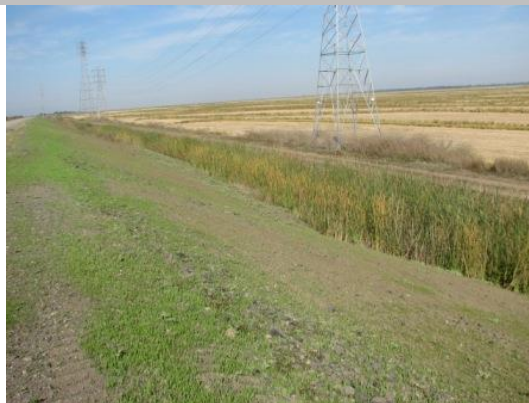
Photo 2 of 3 : SP_2017_RD0787_212_13_20170320_00004.jpg

A view of the agricultural ditch in the fall of 2011.

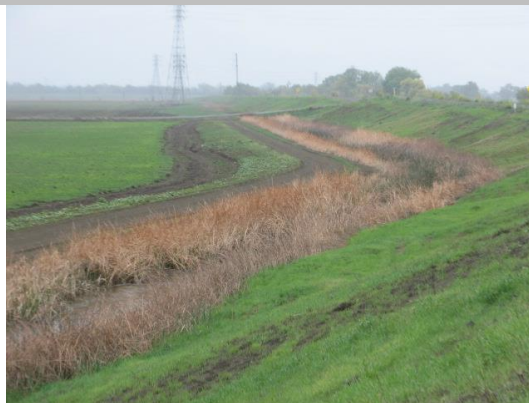
Photo 3 of 3 : SP_2017_RD0787_212_13_20170320_00005.jpg

LM Start	1.58	Rating **	M	Issue No.	13 (cont)	
LM End	2.73	Issue Type +	En	Location *	LS	
Category	Earthen Levee			GPS Latitude/Longitude		
				Start		End
Item	Encroachments			38.801794 °	38.809506 °	
				-121.750204 °	-121.768979 °	
DWR ID	DWR_RD0787_01_s_2012_13					
Comment Code						
DT : Ditch						
Inspector Comment

The agricultural ditch runs along the toe of the levee. Spring 2014

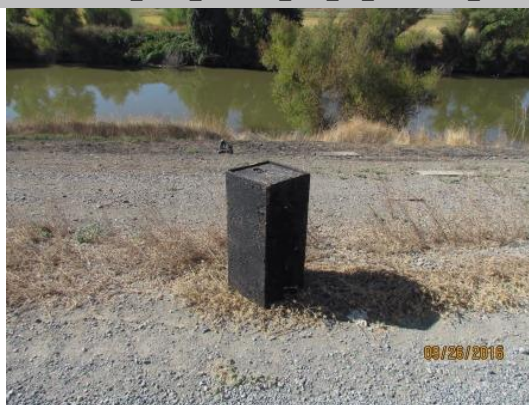
Photo 1 of 1 : SP_2017_RD0787_212_11_20170320_00002.jpg

LM Start	1.73	Rating **	M	Issue No.	11
LM End	1.73	Issue Type +	Ma	Location *	WS
Category	Earthen Levee			GPS Latitude/Longitude	
				Start	End
Item	Encroachments			38.802693 °	38.802693 °
				-121.752672 °	-121.752672 °
DWR ID	DWR_RD0787_01_f_2016_11				
Comment Code					
GA : Garbage					
Inspector Comment

Burnt loudspeaker near levee crown on waterward side. Fall 2016.

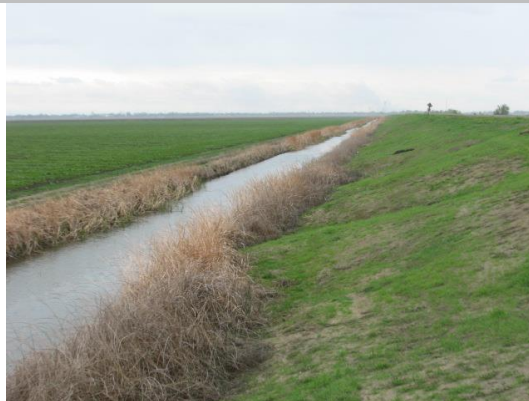
Photo 3 of 3 : SP_2017_RD0787_212_14_20170320_00008.jpg

LM Start	3.13	Rating **	M	Issue No.	14 (cont)
LM End	4.40	Issue Type +	En	Location *	LS
Category	Earthen Levee			GPS Latitude/Longitude	
				Start	End
Item	Encroachments			38.812963 °	38.822302 °
				-121.774880 °	-121.795295 °
DWR ID	DWR_RD0787_01_s_2012_14				
Comment Code					
DT : Ditch					
Inspector Comment

The agricultural ditch runs along the toe of the levee slope. Spring 2014

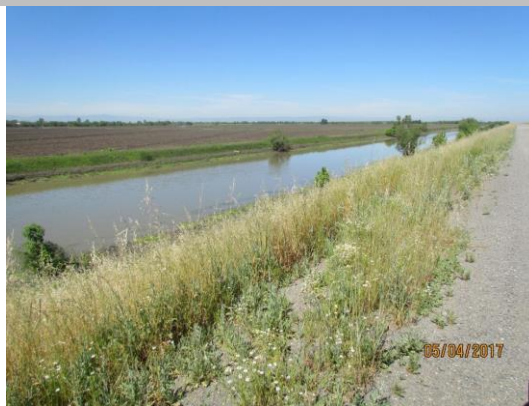
Photo 1 of 1 : SP_2017_RD0787_212_20_20170504_00017.jpg

LM Start	3.58	Rating **	U	Issue No.	20
LM End	4.42	Issue Type +	Ma	Location *	WS
Category	Earthen Levee			GPS Latitude/Longitude	
				Start	End
Item	Vegetation			38.816212 °	38.822494 °
				-121.782124 °	-121.795599 °
DWR ID	DWR_RD0787_01_s_2017_20				
Comment Code					
V1 : Control annual grass and weeds on the levee slopes and easements.					
Inspector Comment

Tall grass on waterside levee slope, blocking visibility. Spring 2017.
